# **COMPOSTING OF SWINE MANURE SLURRY TO CONTROL ODOUR, REMOVE WATER, AND REDUCE POLLUTION POTENTIAL**

N.K. Patni and R.G. Kinsman  
The Centre for Food and Animal Research  
Research Branch, Agriculture and Agri-Food Canada  
Central Experimental Farm  
Ottawa, Ontario, K1A 0C6  
Canada

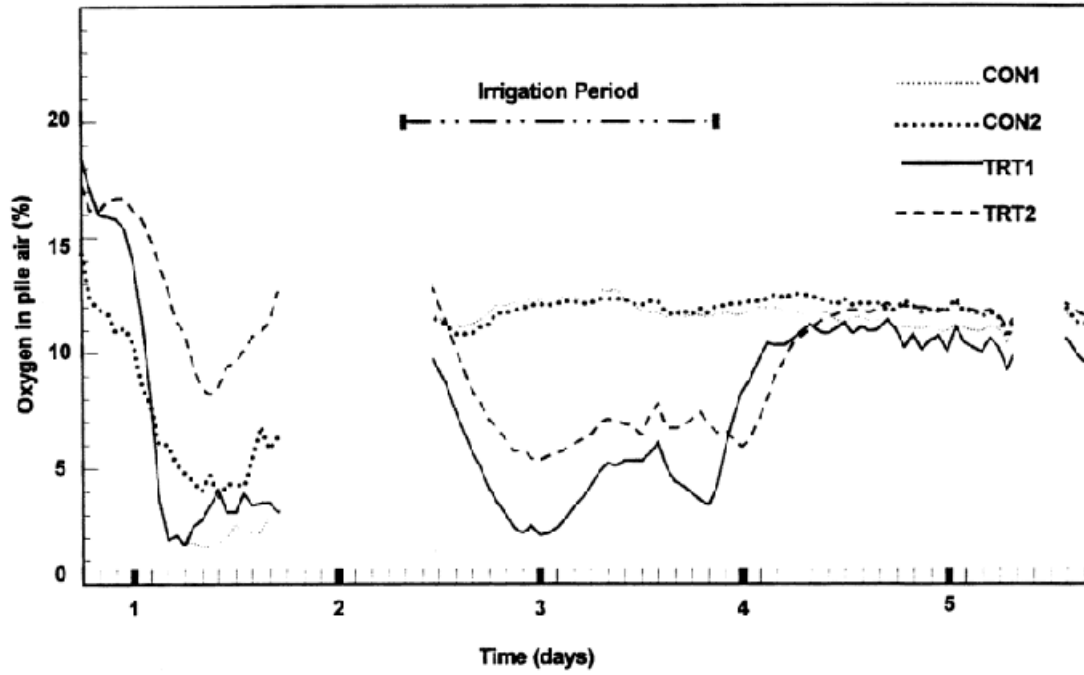
Figure 8. Oxygen content of air in the four piles. Missing data are due to accumulation of condensed moisture in the sampling tubes. Monitoring was discontinued after 6 days.

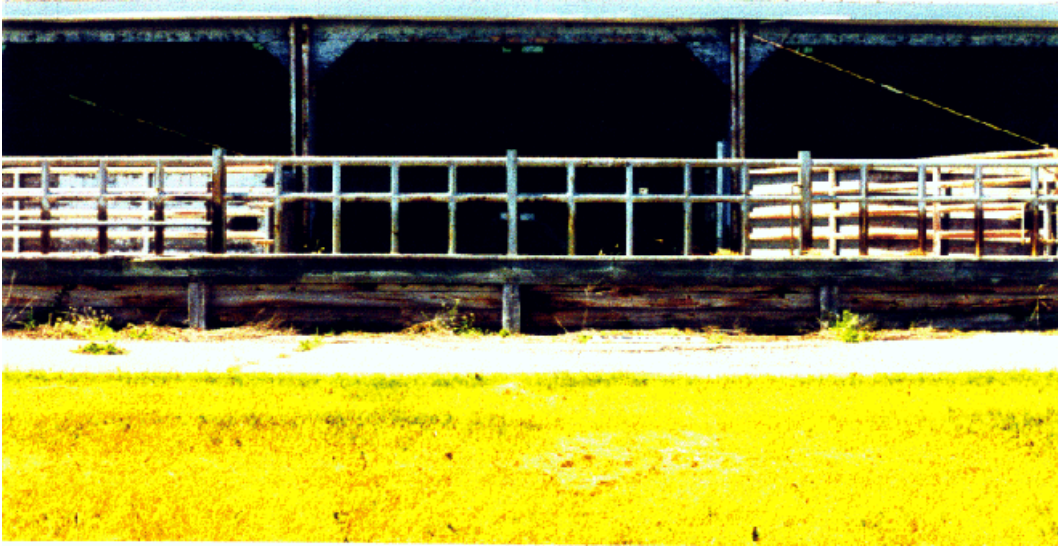
Photo 1. View of the open-front, roofed barn used for compost pile preparation. Two pens were used for two piles in each pen (Photo 11). The treatment (irrigated) piles were located at the open end of the barn.

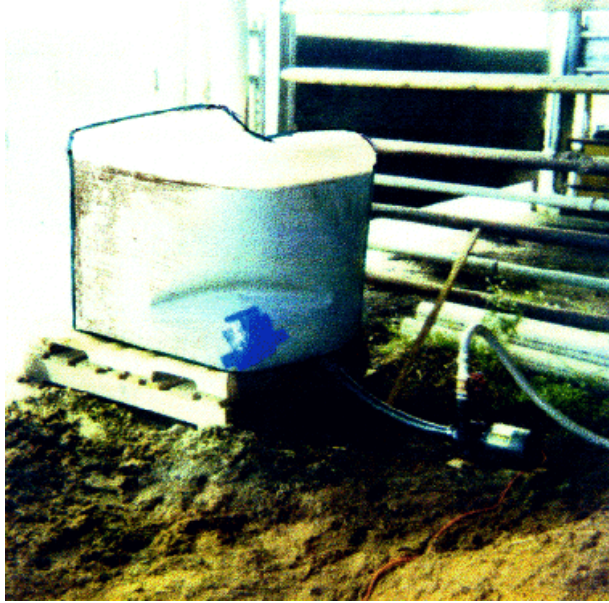
Photo 9. View of the 200-gallon slurry storage tank and the centrifugal pump. One such unit was used for each of the two treatment piles.

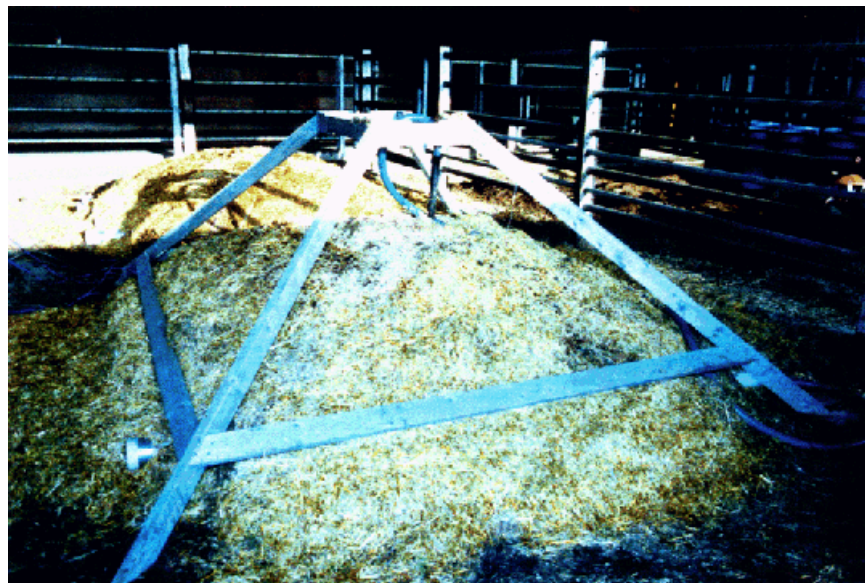
Photo 10. View of the compost piles of straw and swine manure at the end of the 60-day composting period. Initial size of the pile is indicated by the wooden frame.
